## **Advances in urban planning and territorial management in the city of Lorca after earthquake of May 11, 2011**

S. García-Ayllón Veintimilla<sup>1</sup>, Antonio Tomás Espín<sup>1</sup>, Ródenas Quiñonero, J.L.<sup>1</sup>

<sup>1</sup> *Department of Civil Engineering, Technical University of Cartagena (UPCT), Spain.*

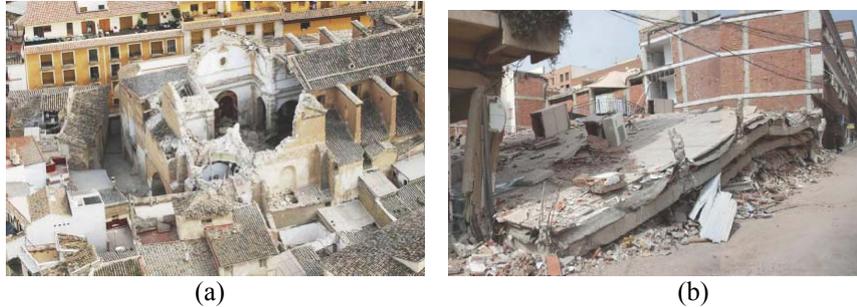
An estimated 80 % of homes were to some extent damaged, with over 1,300 having to be demolished in the following months. However, this distribution of damage was quite heterogeneous and upon analysis did not relate to only seismic parameters. In addition, it should be noted that despite the high number of homes affected, only one building actually collapsed during the earthquake (Fig. 3).

Figure 3. (a) Church of Santiago. (b) Building collapsed in La Viña.

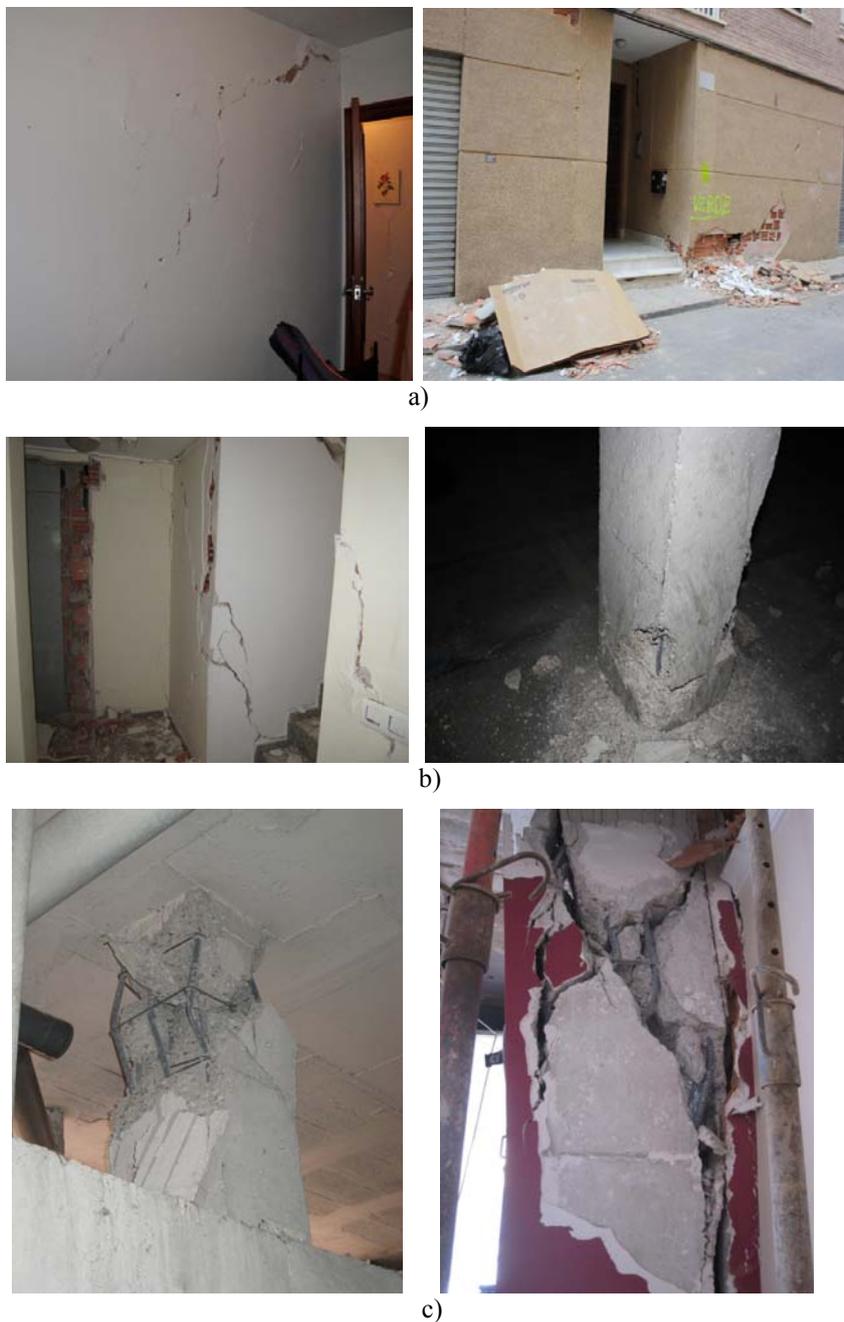
The buildings were classified with green, yellow and red labels. The green classification meant safety of use, although the building could have minor damage such as cracks, crevices or small landslides. The yellow rating indicated a damaged building with access available based on the elimination of risk (e.g. the demolition of damaged roofs or parapets). Use of these buildings could also be cautiously granted as long as they had no more than non-decisive structural damage to their overall stability, following a visual inspection. The red label marked a structurally damaged building, with access to the property being prohibited. In Figure 4, typical damages labelled at green, yellow and red labels, respectively, are showed.

Figure 4. Damages in structural and non-structural elements of buildings after the Lorca earthquake, 2011 typically labelled as a) green label, b) yellow label or c) red label. Source: Authors.

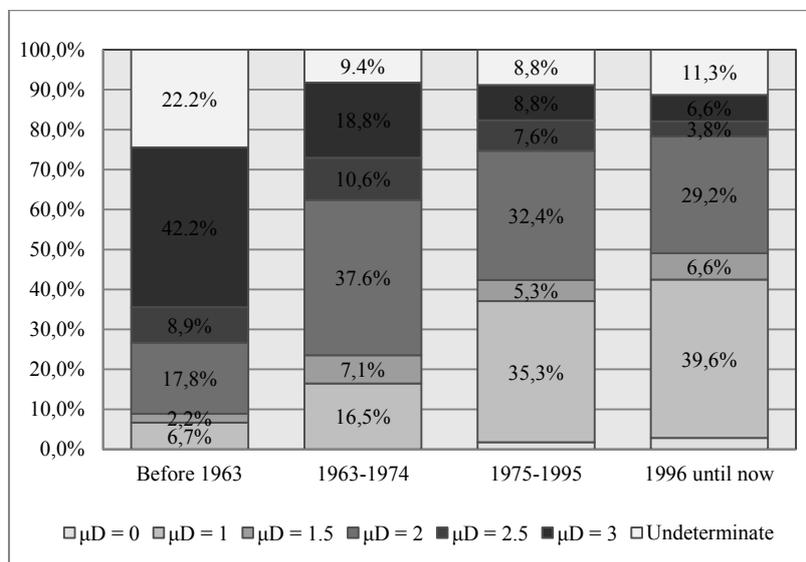
Table 1 shows the age distribution of the analyzed buildings as a function of the constructive periods, defined by considering the Spanish structural and seismic codes. Figure 5 shows the observed damage grade depending on its period of construction. For example, within the group of structures constructed prior to 1963, 42.2 % presented high damage levels ( $\mu D=3$ ) whereas this percentage diminished to 6.6 % in the buildings constructed after 1996. On the contrary, only 6.7 % of the buildings belonging to the first group presented a slight grade of damage ( $\mu D = 1$ ), with this value reaching 39.6 % in the more recently constructed buildings.

Figure 5. Distribution of EMS-98 mean damage grade observed on RC buildings after the Lorca earthquake, according to its period of construction.

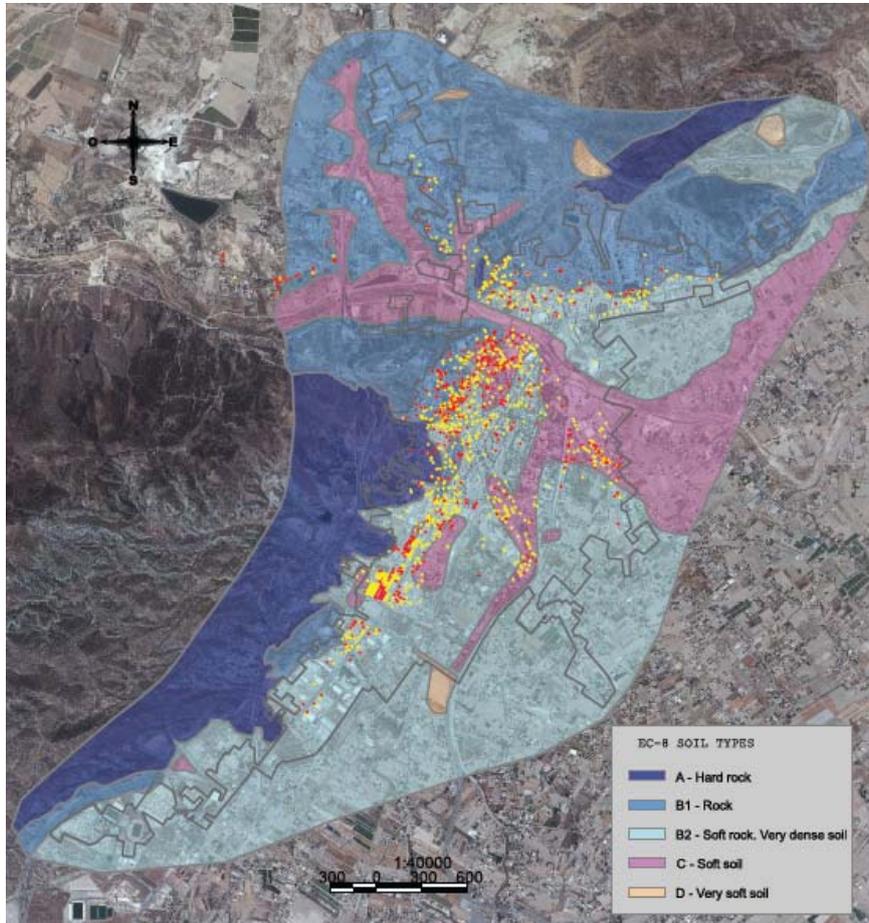
An analysis of the incidence of damage out of the total number of buildings for each soil type shows a clear increase in damage to the soil type  $C$  (or type III in NCSE-02), referring to Guadalentín river sedimentary deposits. This explains cases such as that of the neighbourhood of San Fernando, where the 232 homes from the nine buildings in the neighbourhood had to be completely demolished because of the serious damage.

Figure 7. Overlapping of damage in buildings classified with yellow and red labels over soil types identified in microzonation study of Lorca, according to EC-8 classification.

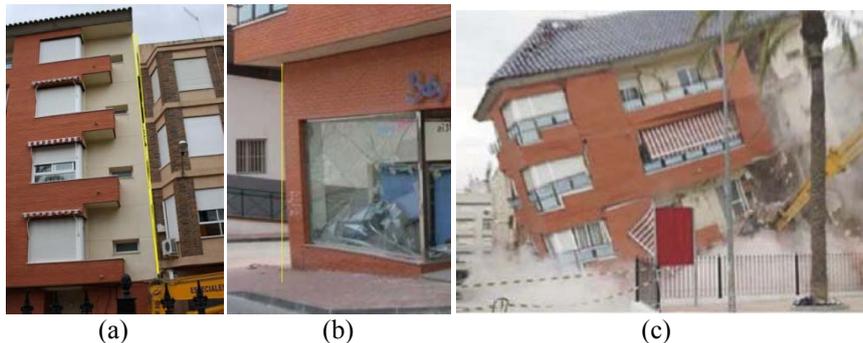
Figure 8. Building in danger of collapse. Evidence of crashes in (a) joint between buildings and (b) corner pillar. (c) Collapse.

For example, the building located in the Aprendices Square had an unexpected collapse during its demolition due to the damage on the ground floor and first floor (Fig. 8). It had, according to its evaluator, only serious damage in facades and the fall of part of the breastplate housing, causing the financial ruin of the building. According to the proposed form, this building would be directly classified as a potential collapse (red label) since it presented foundation settlements and noticeably leaning.

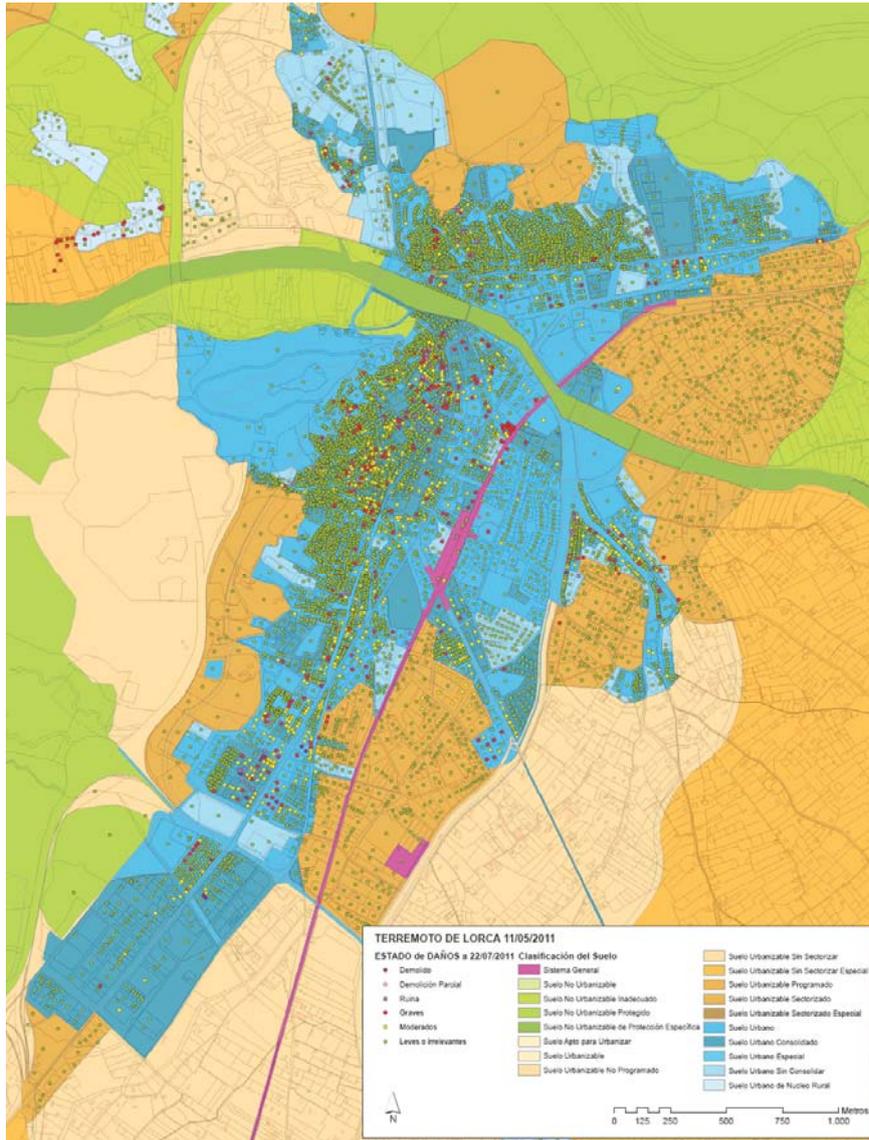
Figure 10. Distribution of damage in urban planning schedule.

A new more technological general plan with urban growth and development, taking into account the territorial results of microzoning performed would reduce as far as possible the seismic vulnerabilities of the city with the proven risk of Lorca and it would be a very useful and innovative tool.
