## **Advances in urban planning and territorial management in the city of Lorca after earthquake of May 11, 2011**

S. García-Ayllón Veintimilla<sup>1</sup>, Antonio Tomás Espín<sup>1</sup>, Ródenas Quiñonero, J.L.<sup>1</sup>

<sup>1</sup> *Department of Civil Engineering, Technical University of Cartagena (UPCT), Spain.*

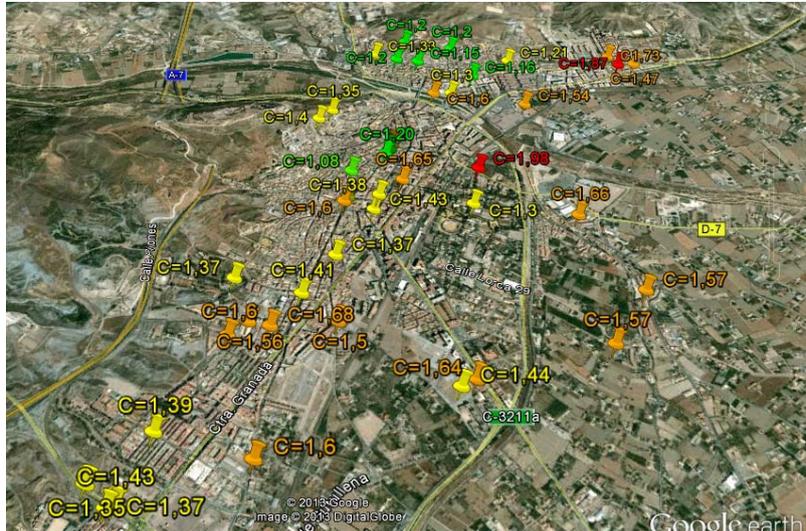
A simple interpolation of this parameter, based on the high number of existing geotechnical studies in the town of Lorca (Fig. 6) allows us to elaborate a zonification that explains certain results of the earthquake.

Figure 6. Inventory of soil amplification factors  $C$  in Lorca, according to NCSE-02 classification.
