Article

Influence of Crystalline Admixtures on the Short-Term Behaviour of Mortars Exposed to Sulphuric Acid

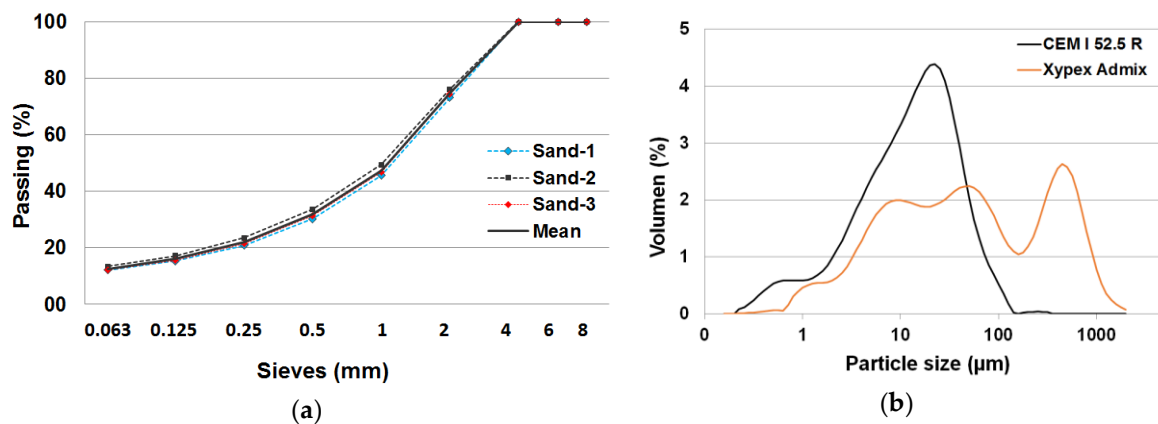
Figure 1. (a) Particle-size distribution of the limestone sand. (b) Particle-size distribution (done by laser granulometry) of the cement (CEM I 52.5 R) and the admixture (Xypex Admix).

The cement used for the manufacture of the mortars was a high early strength type belonging to the European cement class CEM I 52.5 R [38]. Limestone sand was used as a fine aggregate ($D_i/d_i = 0/4$). The particle-size distribution was calculated according to the procedure of UNE-EN 933-1 standard [39]. The distribution was obtained for three samples of sand and the mean values were calculated (Figure 1a). Xypex Admix C-1000 NF (Xypex Chemical Corporation, Richmond, BC, Canada) was added in three different concentrations (1 wt%, 1.5 wt% and 2 wt% of the cement weight) depending on the kind of mortar. The specific surface areas of the cement and crystalline admixture (Xypex Admix) used were 1.48 and 0.642 g/m^2 , respectively (determined by the Brunauer–Emmett–Teller—BET—method), and their particle-size distributions are plotted in Figure 1b. In total, four types of mortars were made: (i) control mortar (A mortar); (ii) mortar with 1 wt% of Xypex (B Mortar); (iii) mortar with 1.5 wt% of Xypex (C Mortar); and (iv) mortar with 2% of Xypex (D Mortar). The dosage used for all mortars was 1 part cement, 0.65 parts water and 3 parts limestone sand.

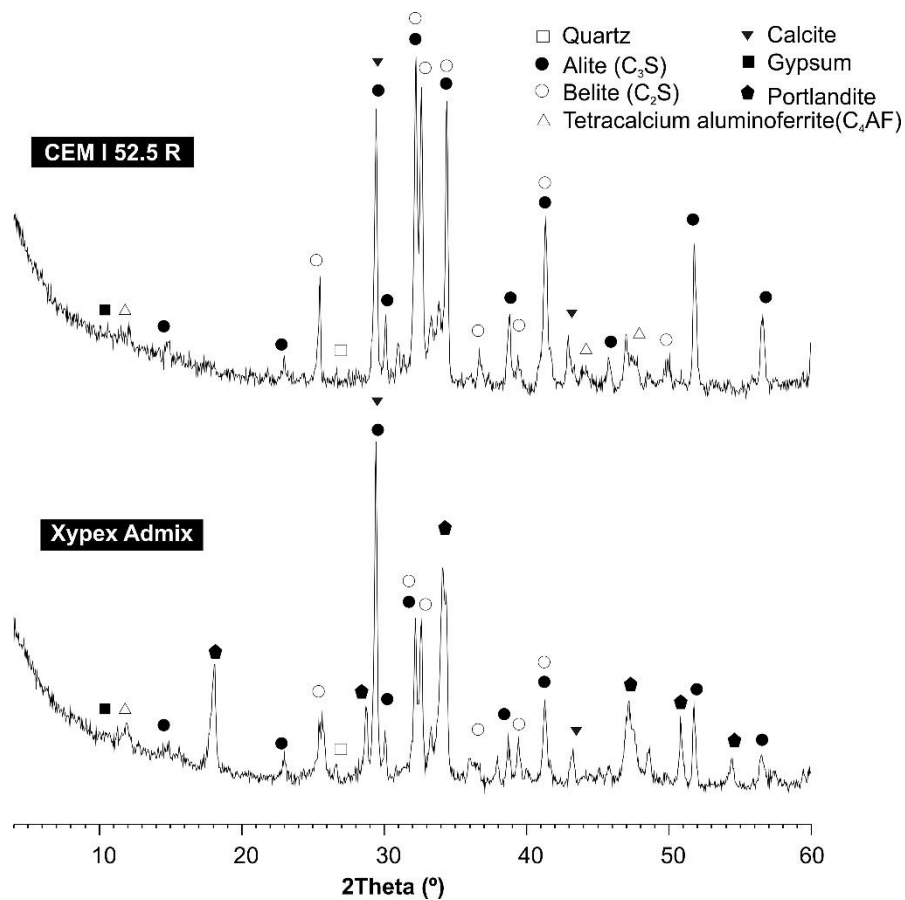
Figure 2. X-ray diffraction (XRD) spectra of cement type CEM I 52.5 R and Xypex Admix.

The XRF results (Table 1) show that both materials were mainly composed of CaO (cement: 55.4%; Xypex: 59.8%) and SiO_2 (cement: 14.9%; Xypex: 8.1%), containing moderate proportions of Al_2O_3 , SO_3 and Fe_2O_3 (percentages between 1.9% and 4.6%). Only the cement contained moderate proportions of MgO (3.3%). The XRD spectra (Figure 2) revealed that both materials had common crystalline compounds, such as alite (C_3S), belite (C_2S), tetracalcium aluminoferrite (C_4AF) and calcite (CaCO_3). Gypsum was only detected in the cement, and portlandite and quartz were only detected in the Xypex

admixture. The peak of portlandite in Xypex Admix may indicate that this admixture was partially constituted by hydrated cement.

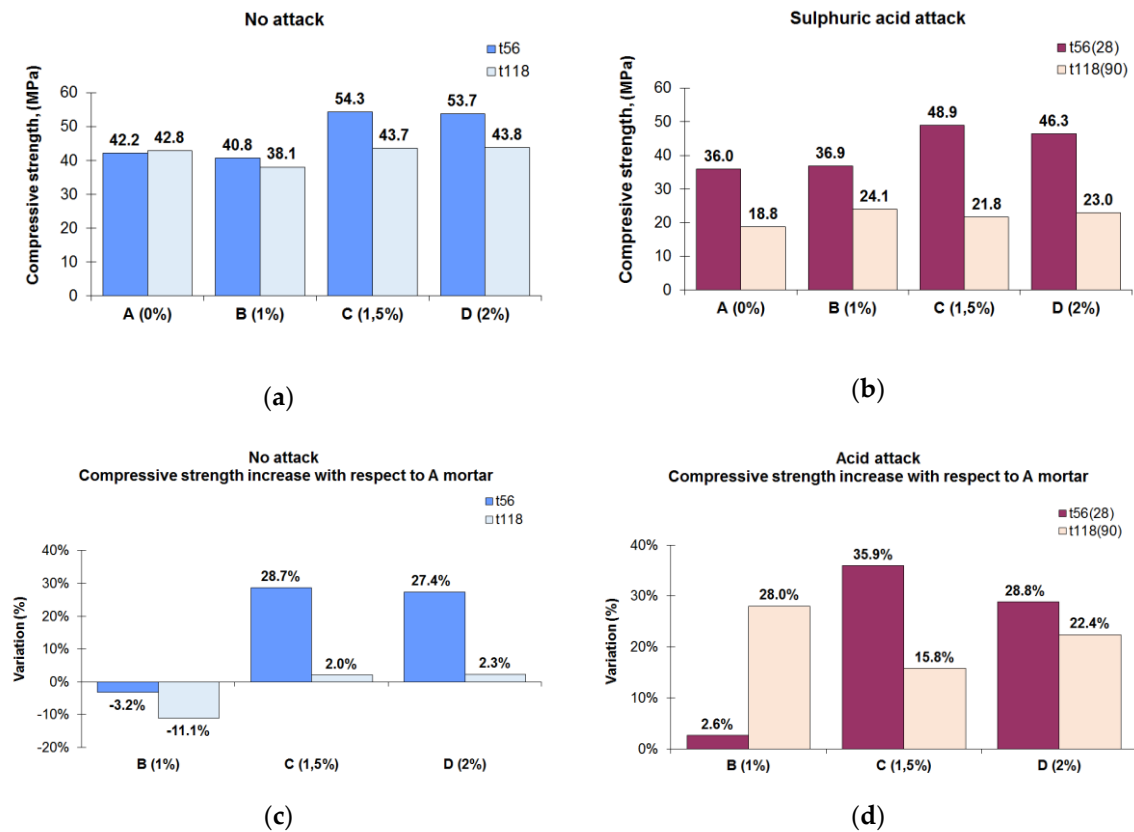
Figure 3. (a) Compressive strength in a nonaggressive environment at t_{56} and t_{118} . (b) Compressive strength in an aggressive environment (sulphuric acid exposure) at $t_{56(28)}$ and $t_{118(90)}$. (c) Compressive strength differences of the mortars with the crystalline admixture with respect to the reference mortar in a nonaggressive environment. (d) Compressive strength differences of the mortars with the crystalline admixture with respect to the reference mortar exposed to sulphuric acid.

The results of the compressive strength tests showed that for a nonaggressive environment (Figure 3a) at t_{56} (56 days from the manufacture of the mortars), the mortars with the highest compressive strength were the C (54.3 MPa) and D (53.7 MPa) types compared with the compressive strength of the A (42.2 MPa) and B (40.8 MPa) mortars. Besides the obvious advantages in the use of the admixtures for mortars, there were drawbacks to take into account. One of those was the lowered final compressive strength compared with nonmodified concretes and mortars using some types of admixtures [48]. In the interval from t_{56} to t_{118} , the only mortar that increased its compressive strength was the reference mortar (A mortar, without crystalline admixture), from 42.2 to 42.8 MPa, whereas in that same period, the three mortars with the crystalline admixture decreased their compressive strength. Usually, admixtures with an accelerated setting effect can reduce the strength of the concrete at later ages. In the high-strength mortars, a mechanism of deterioration of the hardened cement paste phase at the microscopic scale seems to lead to reduced strength at long ages [49]. The C and D mortars clearly had more compressive strength than the reference mortar at t_{56} (B mortar had 28.7% more compressive strength than the A and C mortars (27.7%)), although at t_{118} , this difference was smaller (C mortar: 2%, D mortar: 2.3%) (Figure 3c). It was observed that the C and D mortars exhibited similar compressive strength to the reference mortar at t_{118} , which was in accordance with previous research [33], where the crystalline admixture does not significantly affect the compressive strength of the concretes studied. However, the compressive strength of the B mortar was lower than that of the reference mortar, both at t_{56} and t_{118} .

The compressive strength of the mortars exposed to 28 days of acid attack (56 days after manufacture) followed a pattern similar to that of mortars without acid attack (Figure 3b). The mortars with the highest compressive strength were types C (48.9 MPa) and D (46.3 MPa), and the lowest were types A (36.0 MPa) and B (36.9 MPa). The compressive strength at $t_{56(28)}$ decreased in the same way for all mortar types (due to the acid attack), given as a reference the compressive strength without acid attack, for each mortar with the same curing time (t_{56}). The reduction in compressive strength was a direct effect of the acid attack due to the microcracking caused by the formation of expansive compounds [50,51]. As expected, the compressive strength of mortar type B slightly exceeded the compressive strength of mortar A. When increasing the exposure time of the attack to 90 days ($t_{118(90)}$), the compressive strength of all mortars decreased due to the effects of the attack. In this case, mortars with the admixture (B, C and D mortars) clearly had higher compressive strength compared with the reference mortar (B mortar had 28% more strength than mortars A, C (15.8%) and D (28.8%)) (Figure 3d).

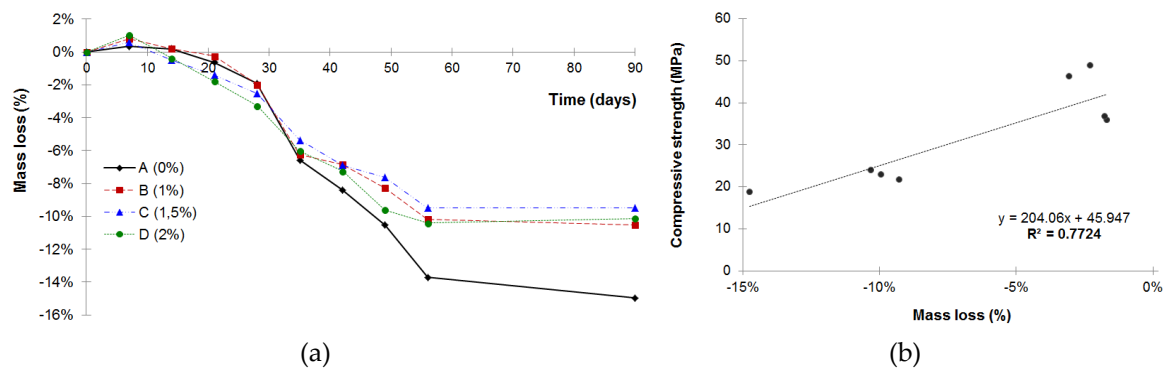
Figure 4. (a) Mass loss due to the sulphuric acid attack. (b) Correlation between compressive strength (MPa) and mass loss (%) after the acid attack.

The results of the mass loss test due to the sulphuric acid exposure (Figure 4a) showed that an acid attack caused a mass loss in mortars so that, as the acid attack continued longer, the mass loss of the mortars was higher. The compressive strength loss described above and the increment in mass loss

when the exposure time increased were consistent with the results obtained in previous studies [43]. Moreover, a linear correlation ($R^2 = 0.7724$) between the decrease in compressive strength and the mass loss was found (Figure 4b). Progression of the acid attack front caused an increase in porosity and permeability, leading to mass and strength loss [52]. Nevertheless, the mortars with the crystalline admixture (B, C and D mortars) behaved clearly better than the mortars without this admixture (A mortar) since they presented lower mass loss (B mortar: 10.5%; C mortar: 9.5 %; D mortar: 10.1%) than the mortar without the admixture (A mortar: 15%).

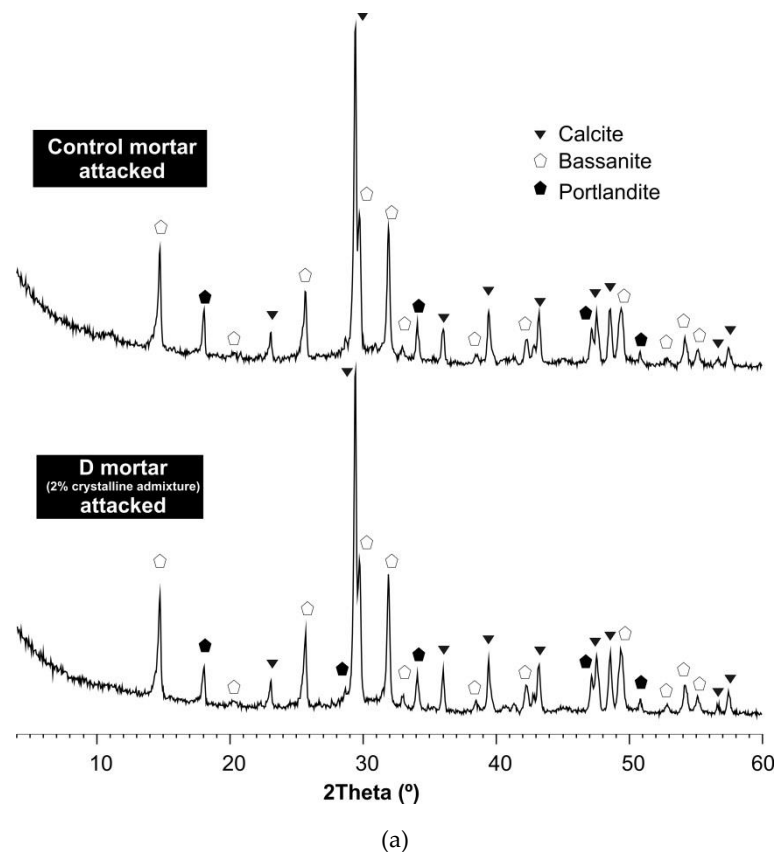
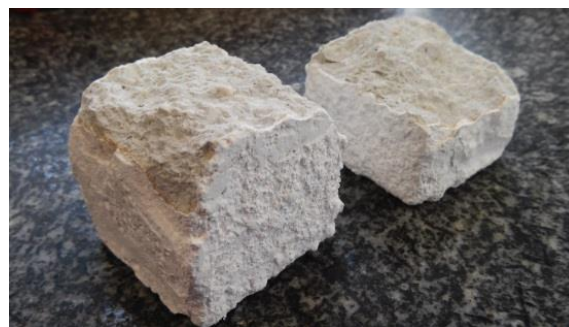
Figure 5. (a) X-ray diffraction spectra of control mortar and D mortar (with crystalline admixture) after 90 days of sulphuric acid attack; (b) Specimens exposed to the acid attack after compressive strength testing at $t_{118(90)}$, where the massive formation of gypsum in the surface of the specimen can be seen.

As a result of the sulphuric acid attack, calcium sulphate (gypsum) was formed by the reaction of the acid with the calcium hydroxide (chemical reaction 2) and calcium silicate hydrate (chemical reaction 3) that were present in the hydrated Portland cement [3,5] and limestone sand (chemical reaction 4) [45,53]. The gypsum coating could also be observed with the naked eye (Figure 5b). The formation of gypsum after a sulphuric acid attack has been confirmed in the literature with XRD studies [52,54]. The chemical reactions produced by the acid attack resulted in a profound degradation of the hydrated cement paste, associated with a loss of compressive strength. When the concrete surface in addition to the acid attack was exposed to flowing water, the products of the degradation were carried away to a significant degree, causing a mass loss. Generally, an attack by free sulphuric acid is more severe than any with a neutral sulphate solution [3]. As mentioned in Section 2.2.1, the specimens were brushed and cleaned weekly to remove the gypsum formed on the specimen surface. The mass loss shown in Figure 4a was mainly associated with the amount of gypsum removed from the mortar surfaces during the brushing process. However, as the literature states [54], at the beginning of an acid attack, there is an increase in mass, which can be explained by the generation of gypsum in the pores and the cement–aggregate interface. This gypsum was difficult to remove even though the surface of the samples was brushed; therefore, at the first stage of the attack, a mass increase was found. To corroborate the existence of gypsum on the surface of the attacked mortars, an XRD analysis was performed. The samples were taken from fragments obtained from the surface of the specimens ($4 \times 4 \times 16$ cm) that had been broken in the compressive tests. The XRD analysis showed the presence of bassanite ($\text{CaSO}_4 \cdot 1/2\text{H}_2\text{O}$), which was the result of the thermal decomposition of gypsum, and it happened at 110°C (chemical reaction 5) [55]. Therefore, it was consistent to find bassanite (hemihydrate phase of gypsum) after having exposed the specimens at $105 \pm 2^\circ\text{C}$ continuously for 24 h. This result confirmed the previous existence of gypsum.

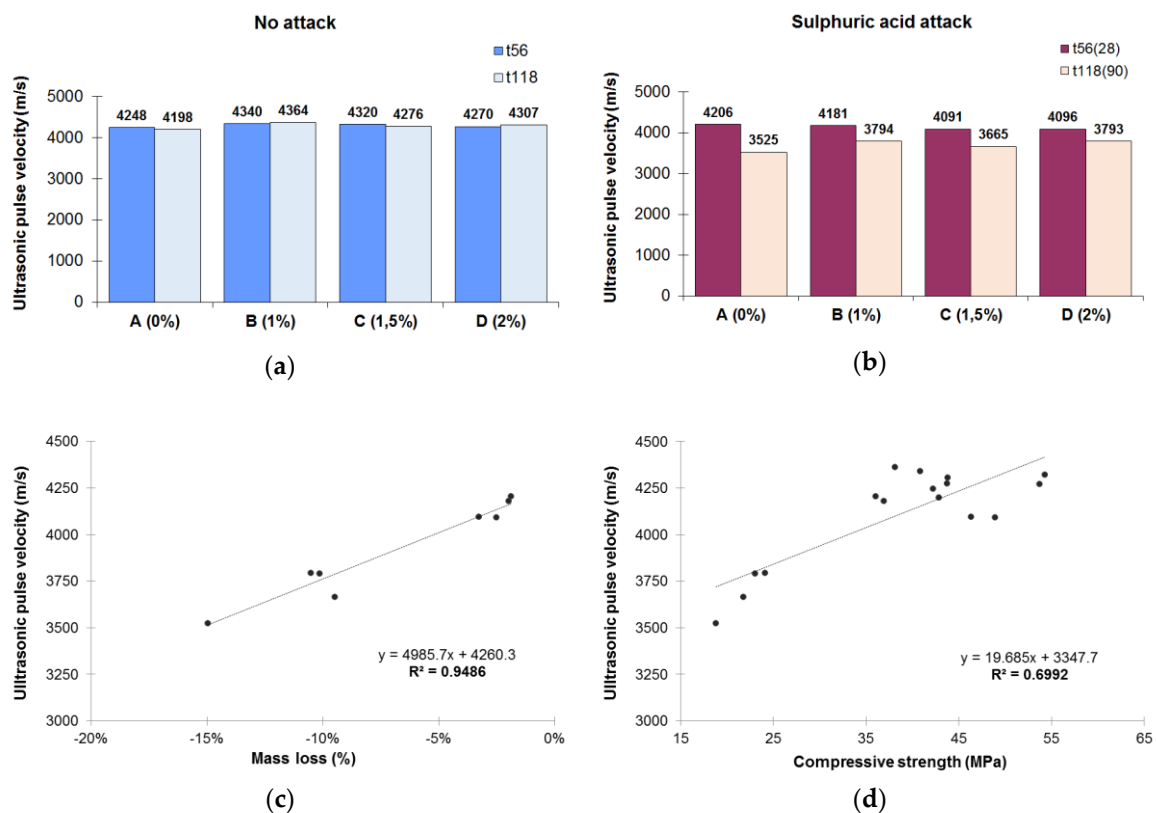
Figure 6. (a) Ultrasonic pulse velocity of mortars kept in a nonaggressive environment at t_{56} and t_{118} . (b) Ultrasonic pulse velocity of mortars exposed to a sulphuric acid solution for 28 and 90 days. (c) Correlation between ultrasonic pulse velocity (m/s) and mass loss (%) after the acid attack. (d) Correlation between ultrasonic pulse velocity (m/s) and compressive strength (MPa).

Figure 6 shows the results of the ultrasonic pulse velocity test. This test consisted of obtaining the velocity (m/s) that the ultrasonic waves needed to cross the longest length of the specimen. The test was performed for mortars maintained in nonaggressive conditions (Figure 6a) and the ultrasonic velocity obtained was similar for all mortars in both t_{56} (from 4248 to 4340 m/s) and t_{118} (from 4198 to 4364 m/s). For mortars exposed to acid attack (Figure 6b), the ultrasonic velocity decreased for all mortars with respect the velocity obtained for a nonaggressive environment for both $t_{56(28)}$ (from 4091 to 4206 m/s) and $t_{118(90)}$ (from 3525 to 3794 m/s). To obtain a measure of the effect of the acid attack on the propagation velocity, the difference between ultrasonic pulse velocity at t_{118} for the mortars with and without attack was calculated. The measurements were taken after 90 days of acid attack, which is an action time long enough for the effects to manifest. It was found that the mortars with the admixture

had less velocity decrease (B mortar: 13.0%, C mortar: 14.3% and D mortar: 11.9%) than the reference mortar (16.0%). In addition, the longer the acid exposure time, the lower the ultrasonic pulse velocity. The results demonstrate that the ultrasonic technique reflects the deterioration caused by sulphuric acid attack, providing information about the internal condition and quality of the mortars [56,57]. This is due to the large amount of cracks in specimens [58]. Indeed, in this work, two relationships between the involved variables were found: (i) correlation between the decrease in ultrasonic pulse velocity and the mass loss, and (ii) correlation between the ultrasonic pulse velocity and the compressive strength (Figure 6c,d). Recent studies have demonstrated [59,60] that the variation of the ultrasonic pulse velocity indicates a variation in Young's modulus. Lower speed means lower Young's modulus and greater deterioration of mortars.

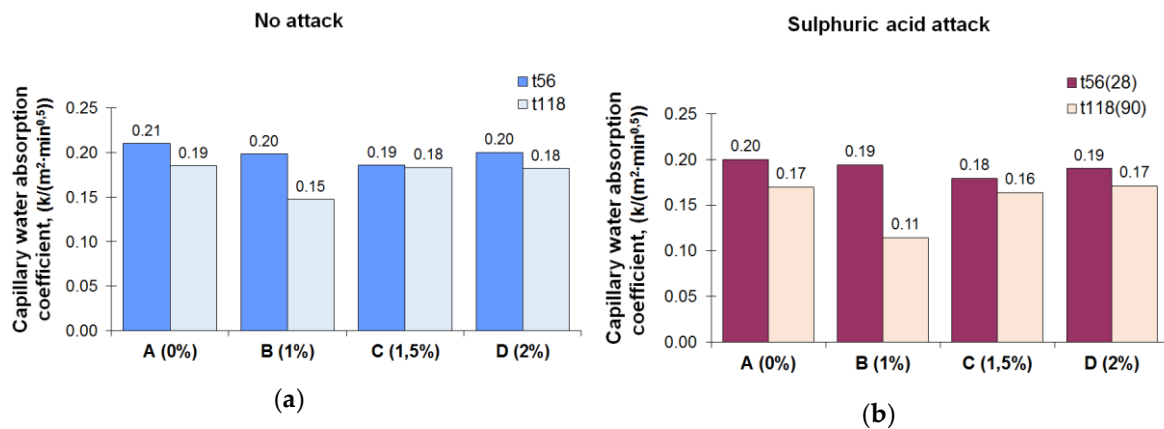
Figure 7. (a) Capillary water absorption coefficients of mortars kept in a nonaggressive environment at t_{56} and t_{118} . (b) Capillary water absorption coefficients of mortars exposed to a sulphuric acid solution for 28 and 90 days.

The results of the capillary water absorption test are shown in Figure 7. For nonaggressive conditions and early ages (56 days from its manufacture), the absorption coefficient of the mortars with the crystalline admixture was slightly lower (B mortar: 0.20; C mortar: 0.19; D mortar: 0.20) than the absorption coefficient of the reference mortar (A mortar: 0.21). At t_{118} , the absorption coefficients for all the mortars reduced but without reaching the values obtained for a water-repellent mortar [25]. These results agree with other studies which found that concretes treated with crystalline materials had slightly lower depth of pressure water penetration than the reference concrete in the short term [36,61] and negligible effects in terms of water vapor permeability [33]. In a sulphuric acid exposure, all mortars slightly reduced their capillary coefficients when compared to the values obtained for those same times in a nonaggressive environment. This reduction could be due to the formation of a gypsum

coating on the surface so that the gypsum crystals obstructed the capillary net, reducing the absorption coefficient [24].

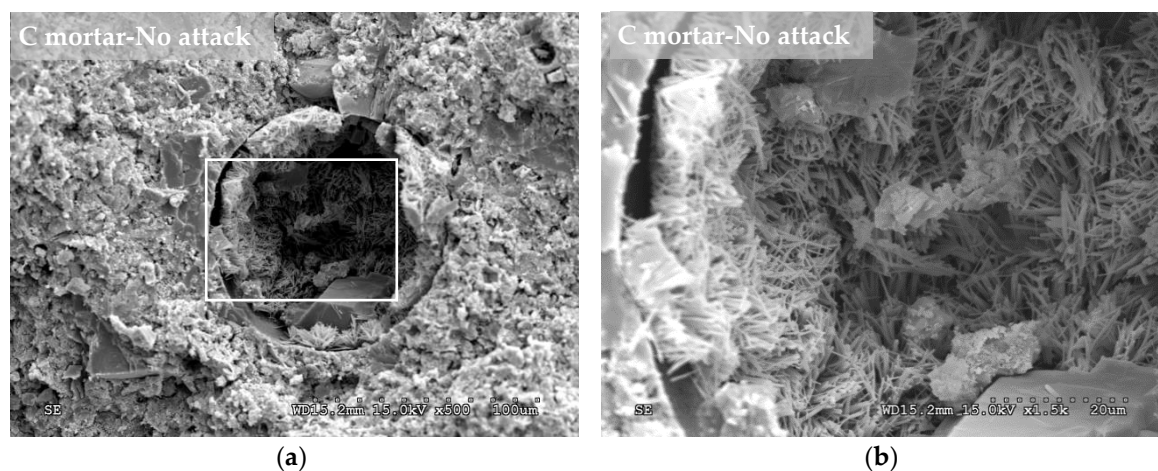
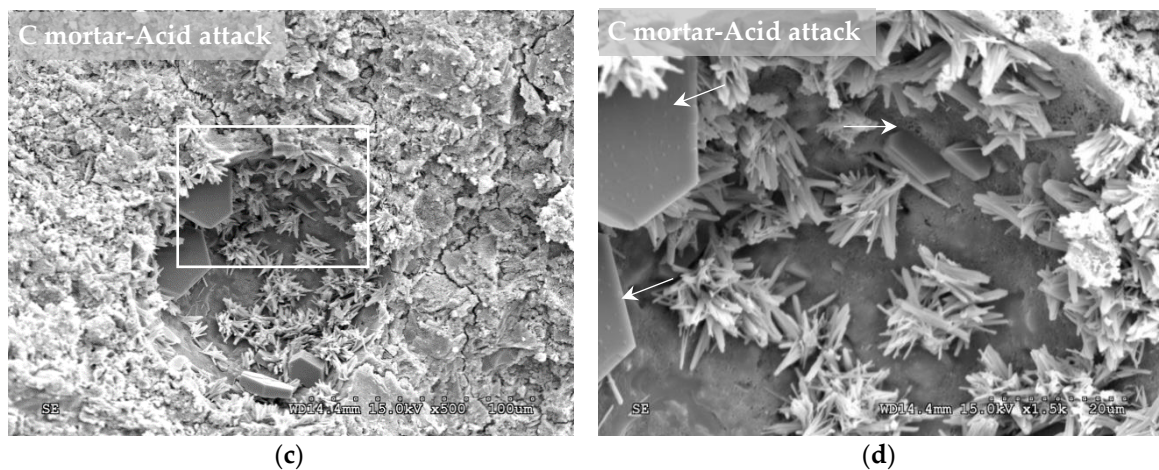
Figure 8. Cont.

Figure 8. Scanning electron microscopy (SEM) images performed at 84 days (12 weeks) from the mortar manufacture. Left (a,c): images at 500 \times magnification. Right (b,d): zoom at 1500 \times magnification on the left image square. Top (a,b): mortar type C (with 1.5% of crystalline admixture) kept in a nonaggressive environment. Bottom (c,d): mortar type C exposed to a sulphuric acid attack for 56 days (8 weeks).

In the SEM images, crystalline structures were observed in the pores of the nonattacked mortars containing the crystalline admixture (Figure 8a,b). These structures had very similar shapes (needlelike crystal) to those that the admixture manufacturer assures are formed when the crystalline chemical reacts with the calcium hydroxide and other by-products of cement hydration. These crystalline formations are insoluble in water and fill and plug pores, capillaries and microcracks of the cementitious materials [62]. In addition, in the mortar manufactured with the Xypex admixture, the typical hexagonal shapes of the portlandite were observed (arrows in Figure 8d). Figure 8c,d shows images of the mortar with the crystalline admixture after being exposed to the sulphuric acid solution for 56 days (8 weeks). It is also possible to observe crystalline formations in the pore but with lower density than for the case of the nonattacked C mortar. The decrease in crystal density may be due to the acid attack that could be reducing the crystalline formations. In the SEM images corresponding to the nonattacked control mortar (Figure 9a,b), the needlelike crystalline shapes described above did not appear. After the acid attack, crystalline forms appeared in the control mortar (Figure 9c,d), which were different from those observed in the mortar with the admixture, and they could correspond to bassanite (hemihydrate phase of gypsum). The bassanite was the result of the effect of the sulphuric acid on the products of cement hydration and was detected in the diffractogram (Figure 5a).

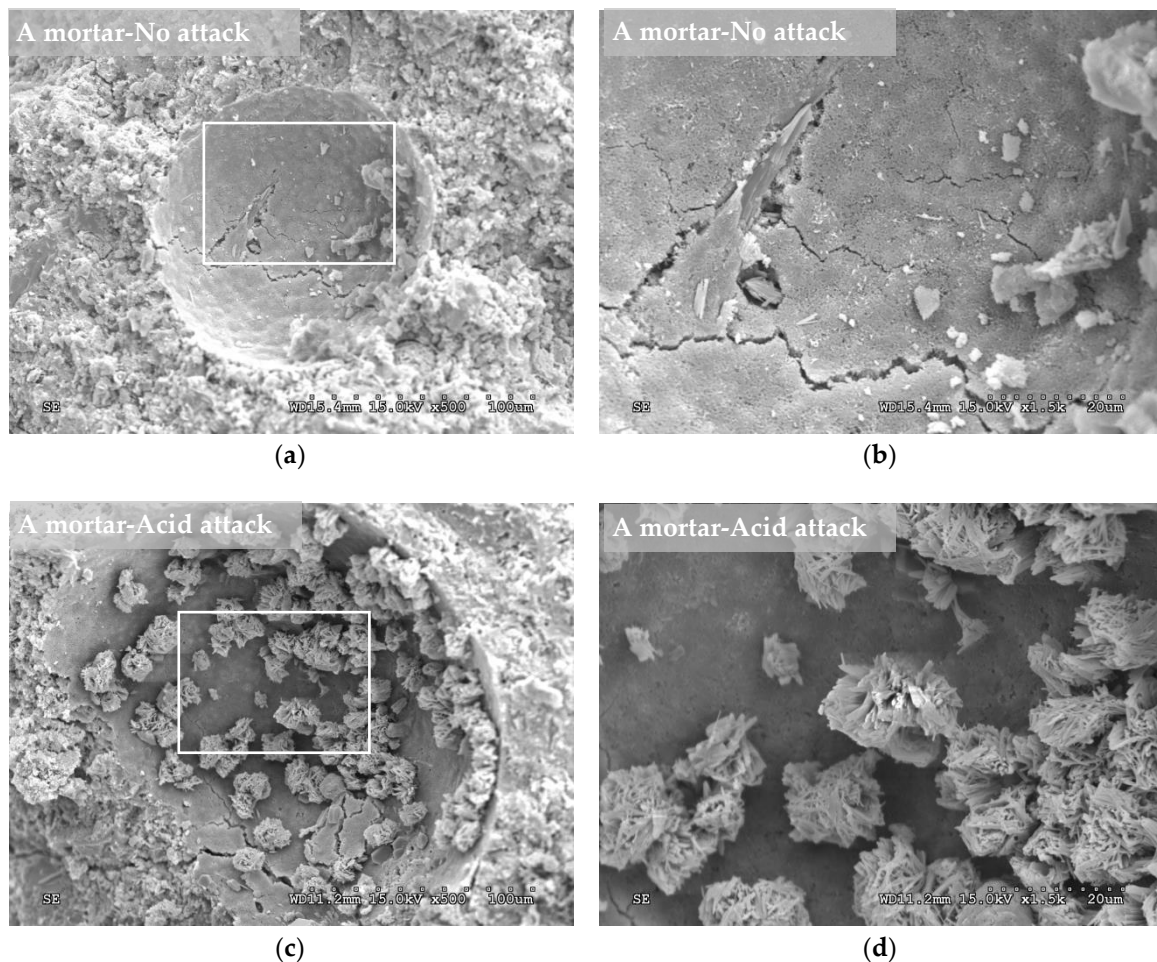
Figure 9. SEM images performed at 84 days (12 weeks) from the mortar manufacture. Left (a,c): images at 500 \times magnification. Right (b,d): zoom at 1500 \times magnification on the left image square. Top (a,b): mortar type A (0% of crystalline admixture) kept in a nonaggressive environment. Bottom (c,d): mortar type A exposed to a sulphuric acid attack for 56 days (8 weeks).
